Smoke and Dye Testing Summary

High Level Sewershed

Run Summary

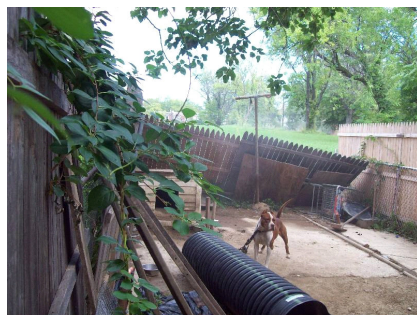
Picture \S1028-076-OB01-P01.jpg

Source Cleanout

Location Yard - back

Comments Smoke from cleanout in back yard. 2812 Violet Ave.

Comments Back of house, 2812 Violet Ave.

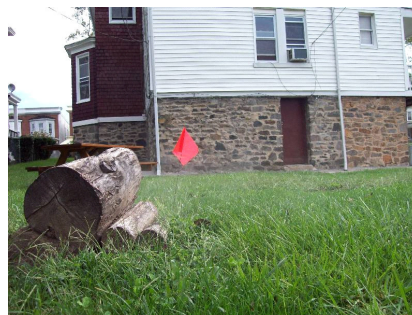
Picture \S1028-076-OB02-P01.jpg

Source Cleanout

Location Yard - back

Comments Smoke from cleanout in back yard. 3700 Reisterstown Rd.

Comments Back of house, 3700 Reisterstown Rd.

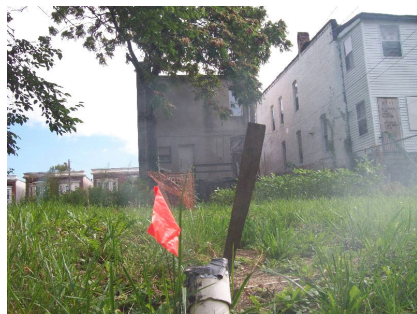
Picture \S1028-076-OB03-P01.jpg

Source Cleanout

Location Yard - back

Comments Smoke from cleanout in back yard. 3710 Reisterstown Rd.

Comments Back of house, 3710 Reisterstown Rd.

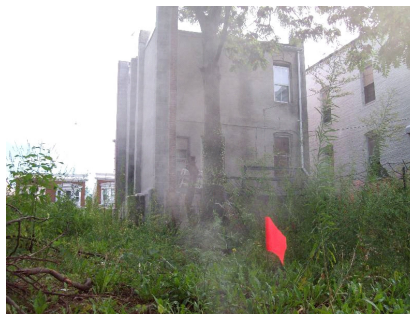
Picture \S1028-076-OB04-P01.jpg

Source Cleanout

Location Yard - back

Comments Smoke from cleanout in back yard. 3712 Reisterstown Rd.

Comments Back of house, 3712 Reisterstown Rd.
